Reserve Study
Lake Community
Property Owners Association
(Barry Lake)

Reference: Lake Community POA (Barry Lake)
Reserve Study
Kipcon Project No. 15887-01

Attached please find Kipcon's Reserve Study, which has been prepared for the Lake Community Property Owners Association (Barry Lake) located in Highland Lakes, New Jersey..

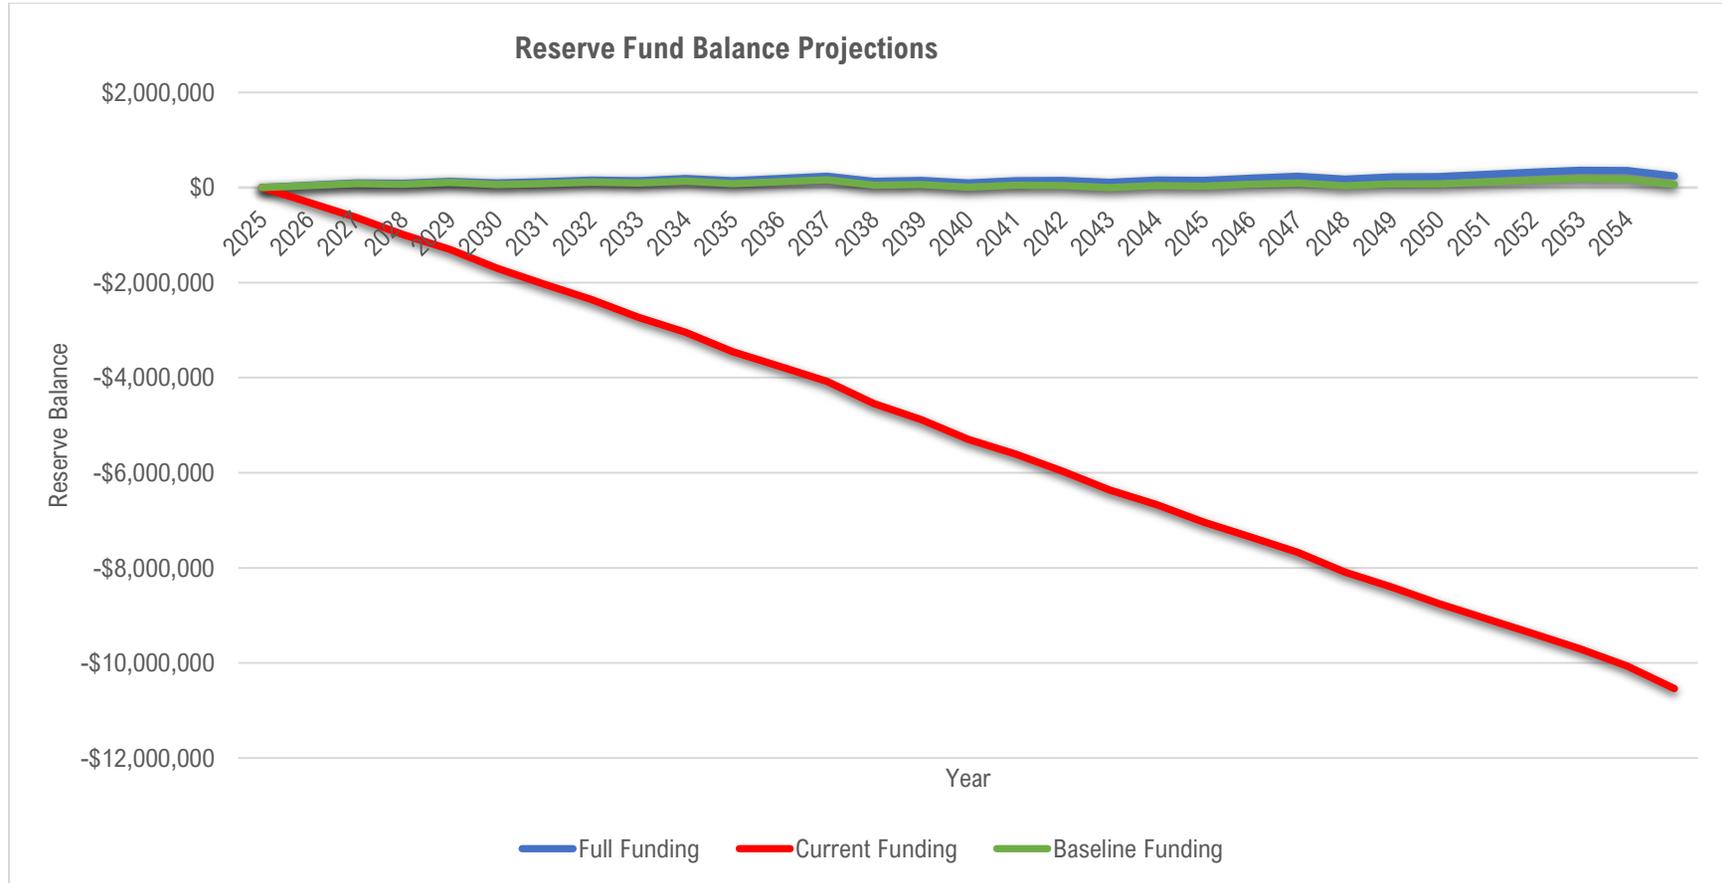
Funding Plan Cash Flow Projections Graph

The Current Funding Analysis is based on maintaining the current annual funding to determine whether this will cause a deficit at some time during the 30-year cash flow period. If the current annual contribution will eventually cause the fund balance to drop below \$0, underfunding is occurring.

This Reserve Study indicates that the Association's reserves are underfunded, as it will result in a deficit within the 30-year projection period used in the funding plans and as required within the legislation. The Association currently is not contributing anything to the reserve fund. Therefore, the reserve fund balance will reach a deficit by 2025. Kipcon has shown a baseline (the riskiest) and a full funding scenario. As part of these analyses, it is recommended that the Association increase their annual contribution in-2025 to \$353,320 for baseline and \$359,475 for full funding. Please note that since there is currently no contribution to the reserve fund Kipcon could not provide an incremental threshold funding plan .However, we can develop a threshold funding recommendation based on a lowest balance that the Association can implement to keep their reserve fund healthy. These should be discussed with Kipcon so the Association can choose the best funding scenario for their community.
